Evaluation Report

595

Hesston 8100 Self-Propelled Windrower

HESSTON 8100 SELF-PROPELLED WINDROWER

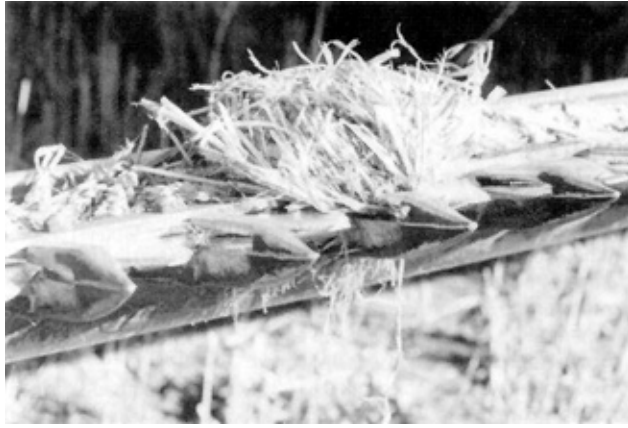
In green, tough or weedy crops, material collected around the guards at the knife overlap (FIGURE 3) resulting in irregular cut stubble. This area required frequent cleaning about every hour in these conditions. The knife should be maintained in good condition to provide clean cutting.

FIGURE 3. Knife Plugging.

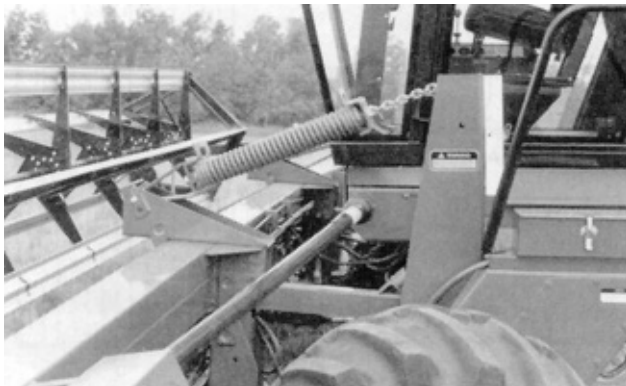
Flotation was provided by four tension springs (FIGURE 4). Header flotation minimized cutterbar damage in stony fields and enabled the header to follow most ground contours.

FIGURE 4. Header Flotation System.

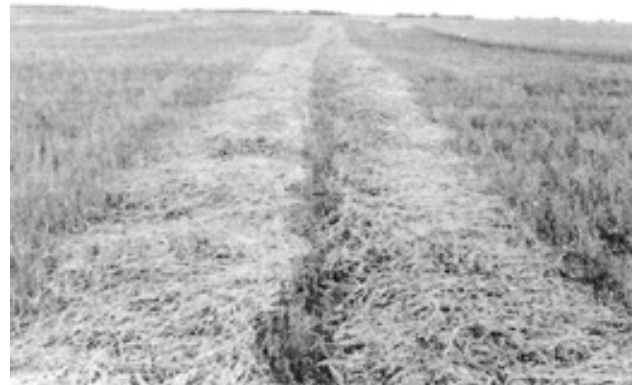
FIGURE 7. Wheat, Double Windrow: 35 bu/ac (2.3 t/ha).

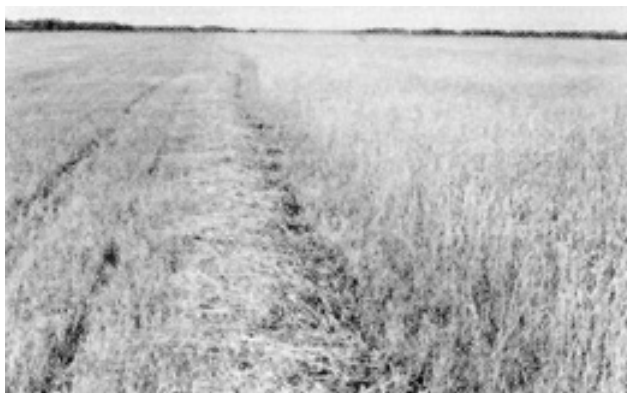
When double windrowing, the right divider draper laid the first windrow about 24 in (610 mm) from the standing crop edge (FIGURE 5). This kept the divider from snagging the windrow on the second pass.

FIGURE 5. First Pass While Double Windrowing.

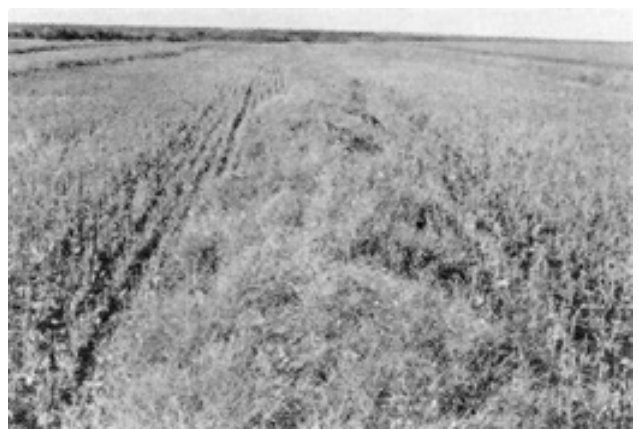
FIGURE 8. Canola, Single Windrow: 30 bu/ac (1.7 t/ha).

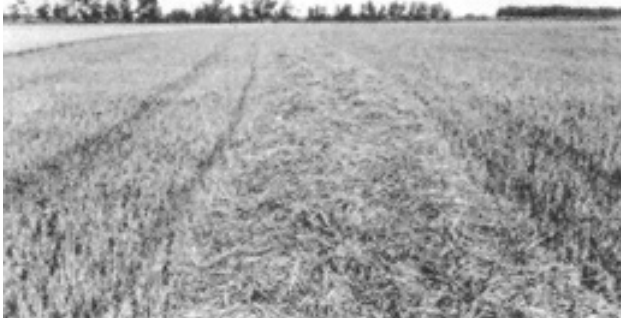
FIGURE 9. Barley, Double Windrow: 40 bu/ac (2.2 t/ha).

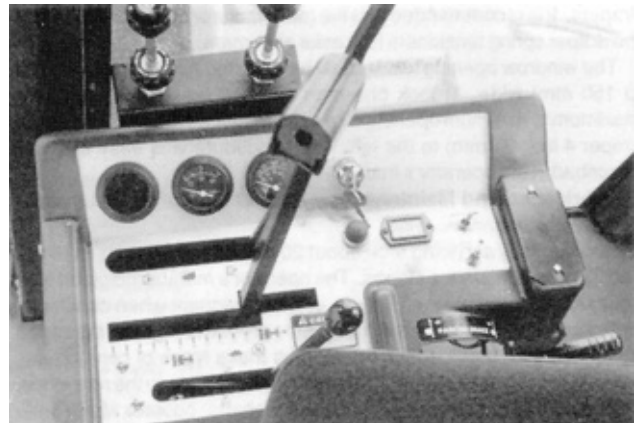
All controls were conveniently located (FIGURE 11). The travel speed control lever and header clutch lever were conveniently located and easy to engage.

FIGURE 11. Operator Station Instruments and Controls.

Reel and draper speed controls were not identified in the cab. It is recommended that the manufacturer consider labeling the draper and reel speed controls.

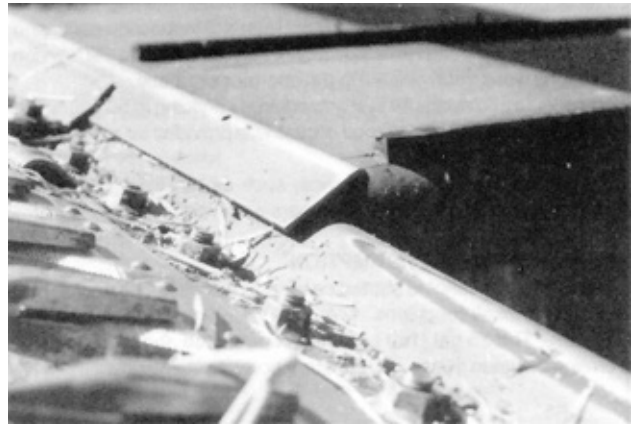
The sliding draper decks derailed on several occasions, while shifting for alternate end delivery. Dirt and crop material collected under the warped draper slides (Figure 12) preventing smooth operations. Also, the draper stops were not effective in keeping the decks in position. It is recommended that the manufacturer consider modifications to improve the sliding draper decks.

FIGURE 12. Draper Deck Slide.

The sliding draper decks were warped up at their ends. The stops for the sliding draper decks were not effective in keeping the draper decks in position. This caused the right draper to derail after it overran the stop and collided with the divider draper. Also, dirt and crop material collected under the draper slides preventing smooth operation. Recommendations regarding the draper decks have been made.

1. Modifying the draper drive to provide adequate speeds under heavy load.
2. Modifications to improve the sliding draper decks.
3. Labeling the draper and reel speed controls.
4. Supplying more rear weights with the windrower when equipped with a 30 ft (9.1 m) header.
5. Improving the draper spring tensioners for easier alignment.
6. Showing all grease fitting locations and providing instructions for adjusting reel clearance in the operator's manual.
